MANCHESTER OPERA HOUSE CASE STUDY

Saniflo helps the show go on

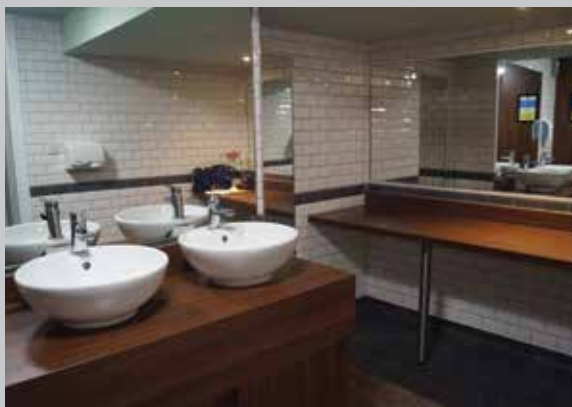
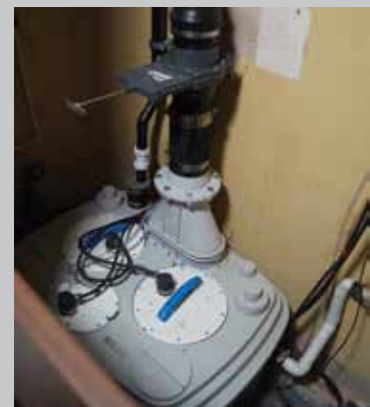
A larger commercial unit was recommended and duly installed. The Sanicubic 2 XL features a vortex system that eliminates the need for blades and can handle larger items without affecting performance. The unit features twin pumps, so in the event of one failing the other will assume responsibility for the whole workload until a fix is found. It also has twin alarms that connect to the Buildings Management System for early warning of problems and for remote checking of the unit at all times. A 4” isolation valve was specified for ease of servicing along with a carbon filter to neutralise odours and gaseous contaminants.

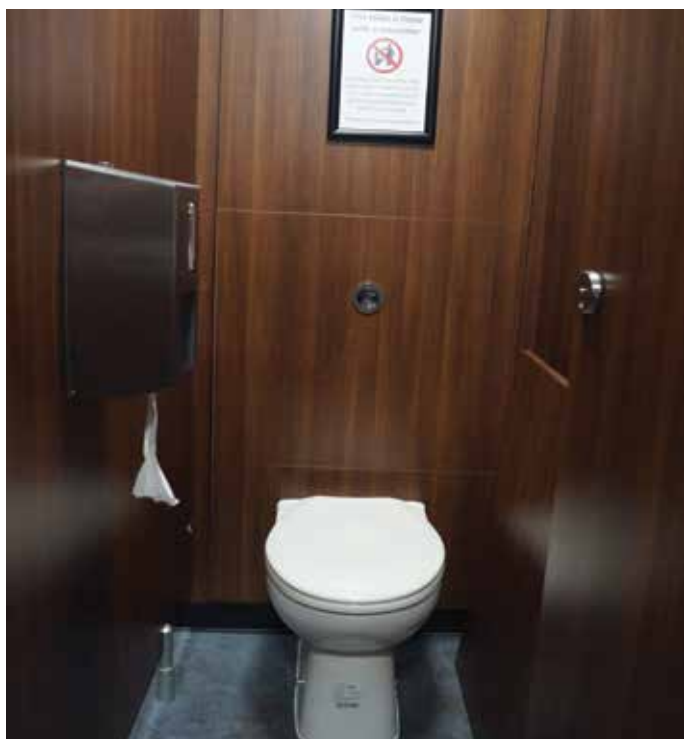
Access to the Sanicubic 2 XL for routine servicing and maintenance is simple thanks to the demountable panel on the right of this cubicle.

The Sanicubic 2 XL was installed by Lightwater Mechanical of Sheffield behind a de-mountable panel in a WC cubicle to enable easy access to the unit for maintenance and servicing. Waste water is pumped up two levels to a mezzanine floor where it is plumbed into existing pipework that uses gravity drainage to discharge the waste to mains drains at street level.

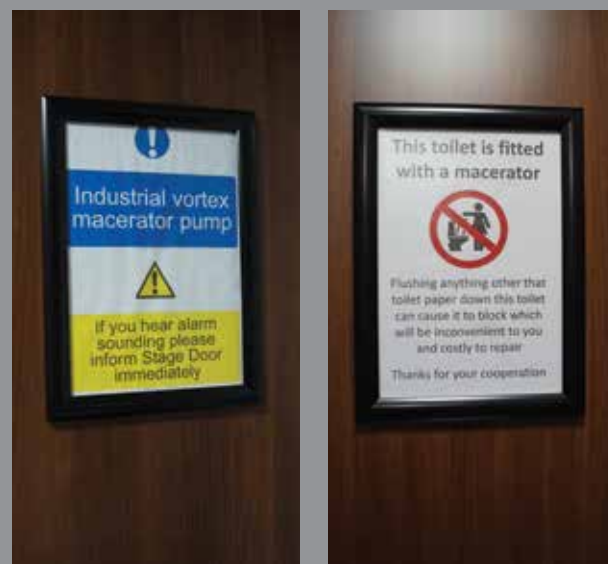
Clear information is now given to the users about items that can be disposed of via a macerator and the chance of an audible alarm warning in the event of a malfunction. The Sanicubic 2 XL can in fact deal with larger items, but the maintenance team is now trying to eliminate the flushing of items other than tissue and waste.
