The Fire Resistance Performance of a Loadbearing Timber Floor Assembly Protected by a Plasterboard Ceiling Designed to Provide 30 minutes Fire Resistance, Incorporating Twenty Three Downlight Fittings, When Tested Accordance with BS EN 1365 - 2: 2014

WF Report No: 385023-B

Integral LED

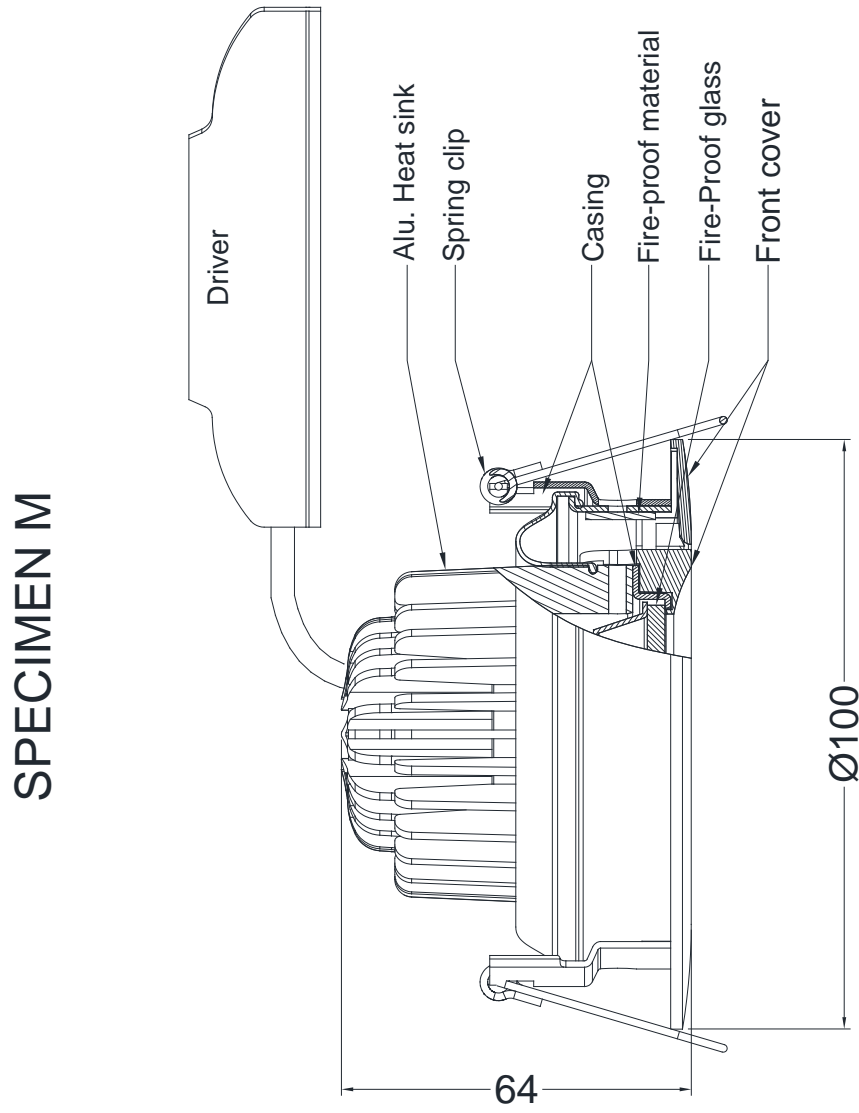
Figure 4 – Details of Downlighters Specimen M

SPECIMEN M

Tilttable
With reflector ILDLFR92CXXX
Cut out: Ø92

11. Specimen J	: Item reported separately
12. Specimen K	: Item reported separately
13. Specimen L	: Item reported separately
14. Specimen M	
Manufacturer	: Integral LED
Type	: Round, tiltable, LED recessed downlight
Reference	: ILDLFR92CXXX
Materials

i. casing	: Mild steel
ii. front cover	: Die cast aluminium
iii. heat sink	: Die cast aluminium
iv. spring clip	: Stainless steel
v. gasket	: 4.3 mm wide x 1.7 mm thick flexible plastics ring
Overall dimensions and construction	: See Figure 15 for details
Cut out size	: 92 mm diameter
Driver	: None
Lamp	: COB
